Marshall Fire Investigative Summary and Review

Michael T. Dougherty
District Attorney - 20th Judicial District

Curtis Johnson
Boulder County Sheriff

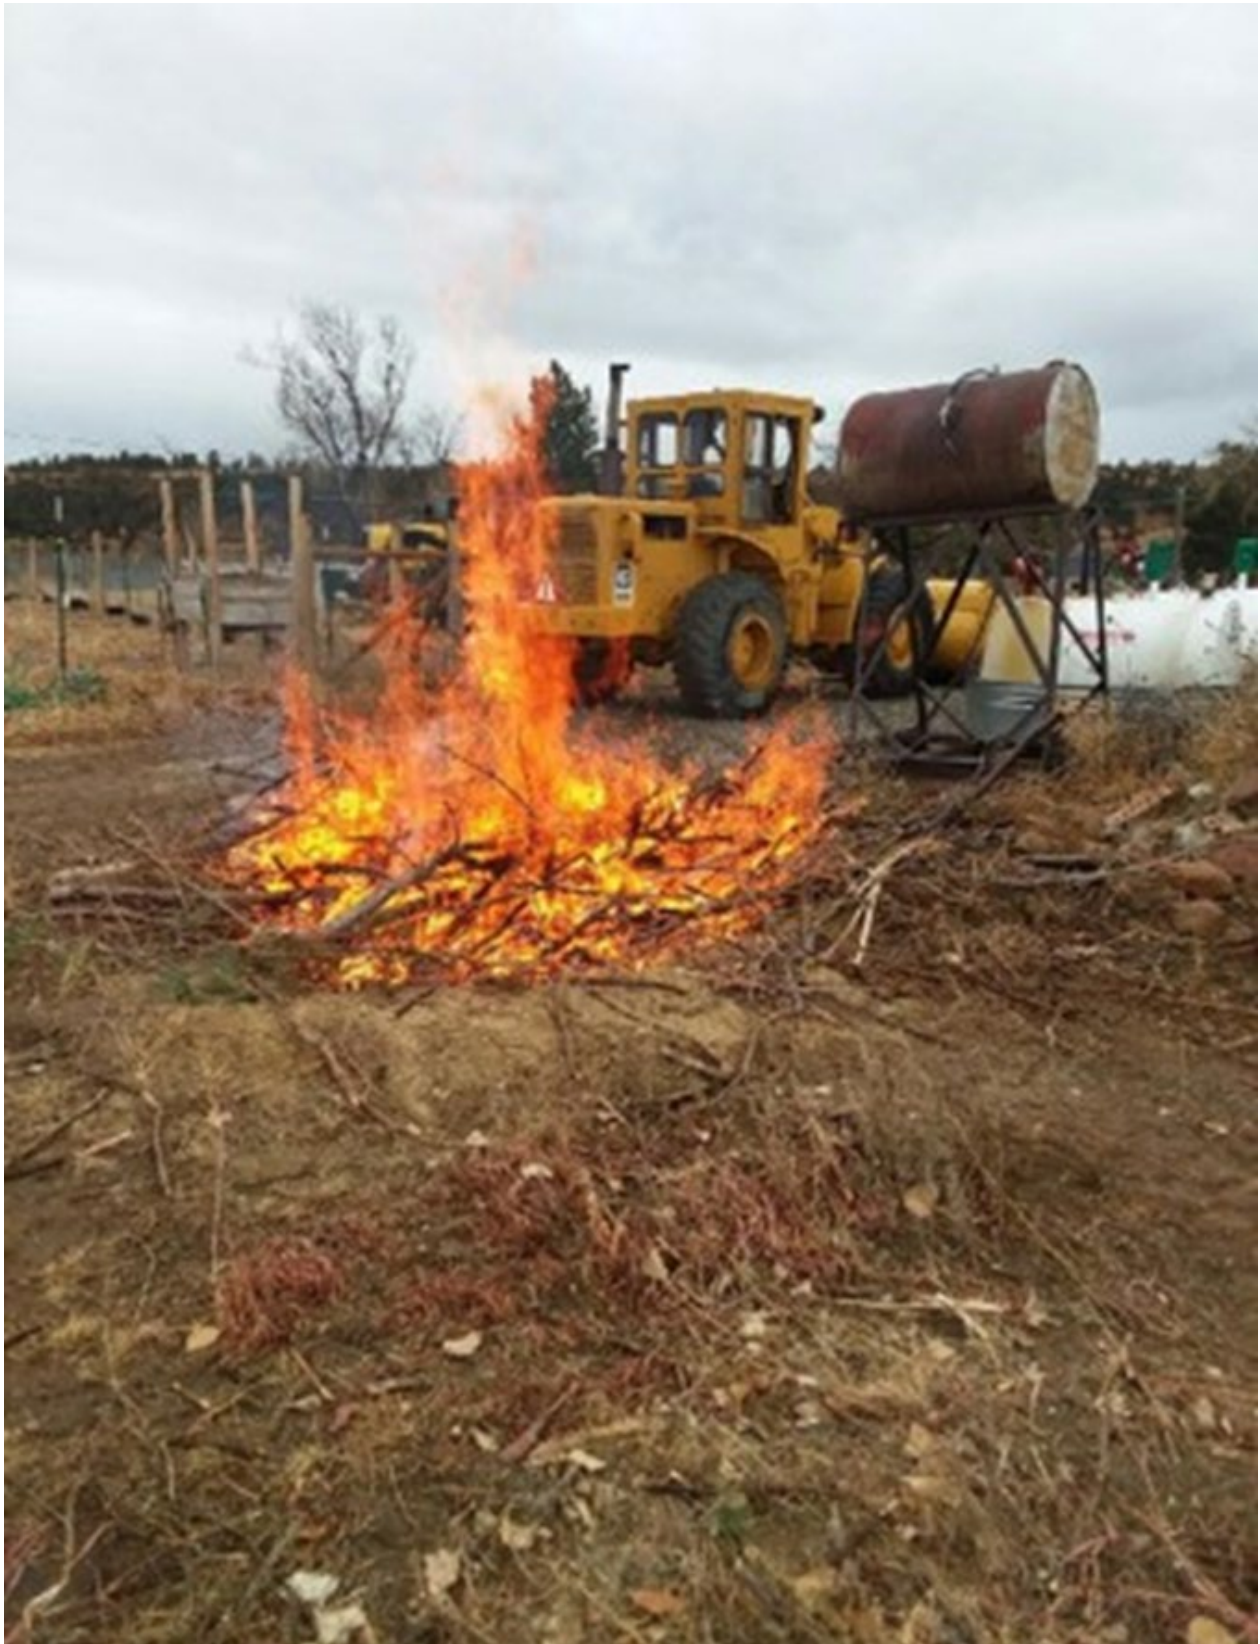
Exhibit 1

On December 24, 2021, residents of 5325 Eldorado Springs Drive intentionally started a fire on their property. At approximately 11:52 a.m. that morning, the Boulder County Sheriff's Office Communications Center received a call from a community member concerned with the size of the fire. Members of the Mountain View Fire Protection District, a Boulder County Sheriff Deputy, and a Boulder Open Space and Mountain Park Ranger were dispatched. A photo of the fire is included in this summary. (*See Exhibit 1.*)

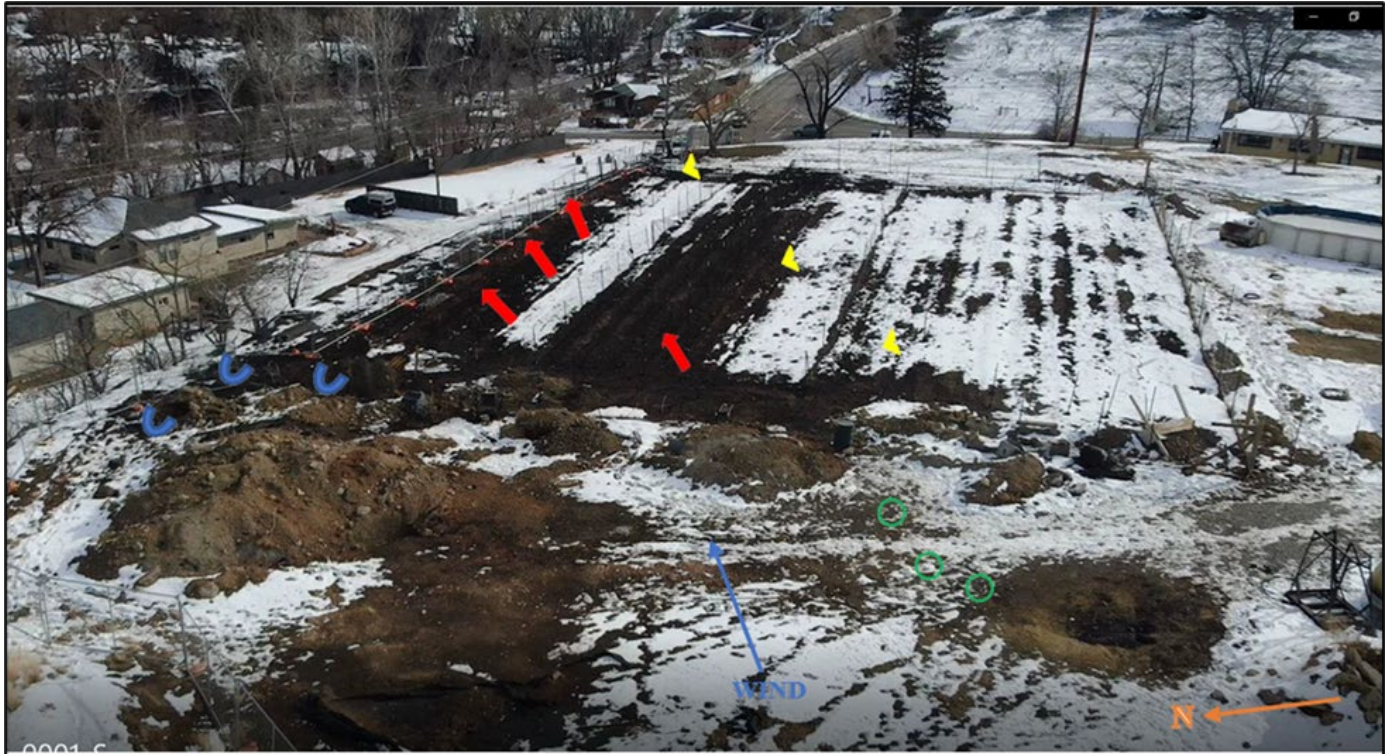
Exhibit 2

United States Forest Service Special Agent Travis Lunders concluded that the extraordinarily high winds uncovered the buried December 24, 2021, fire and exposed still-smoldering embers to fresh oxygen. The wind blew these embers across the property and started a grass fire:

The windblown embers landed in dry grassy fuels along the western fence line of a garden area down wind of the debris burn location. The growing fire ignited chipped wooden mulch which covered the garden surface. Burning wooden mulch was blown across and from the garden in the extreme westerly winds. The exact area of ignition was not located due to the ignition source being consistent with the receptive fuels located near the fence line. The amount of disturbance as a result of the fire suppression effort in and near the specific origin area impacted the investigators' ability to identify the exact area of ignition.

(See Exhibit 2.)

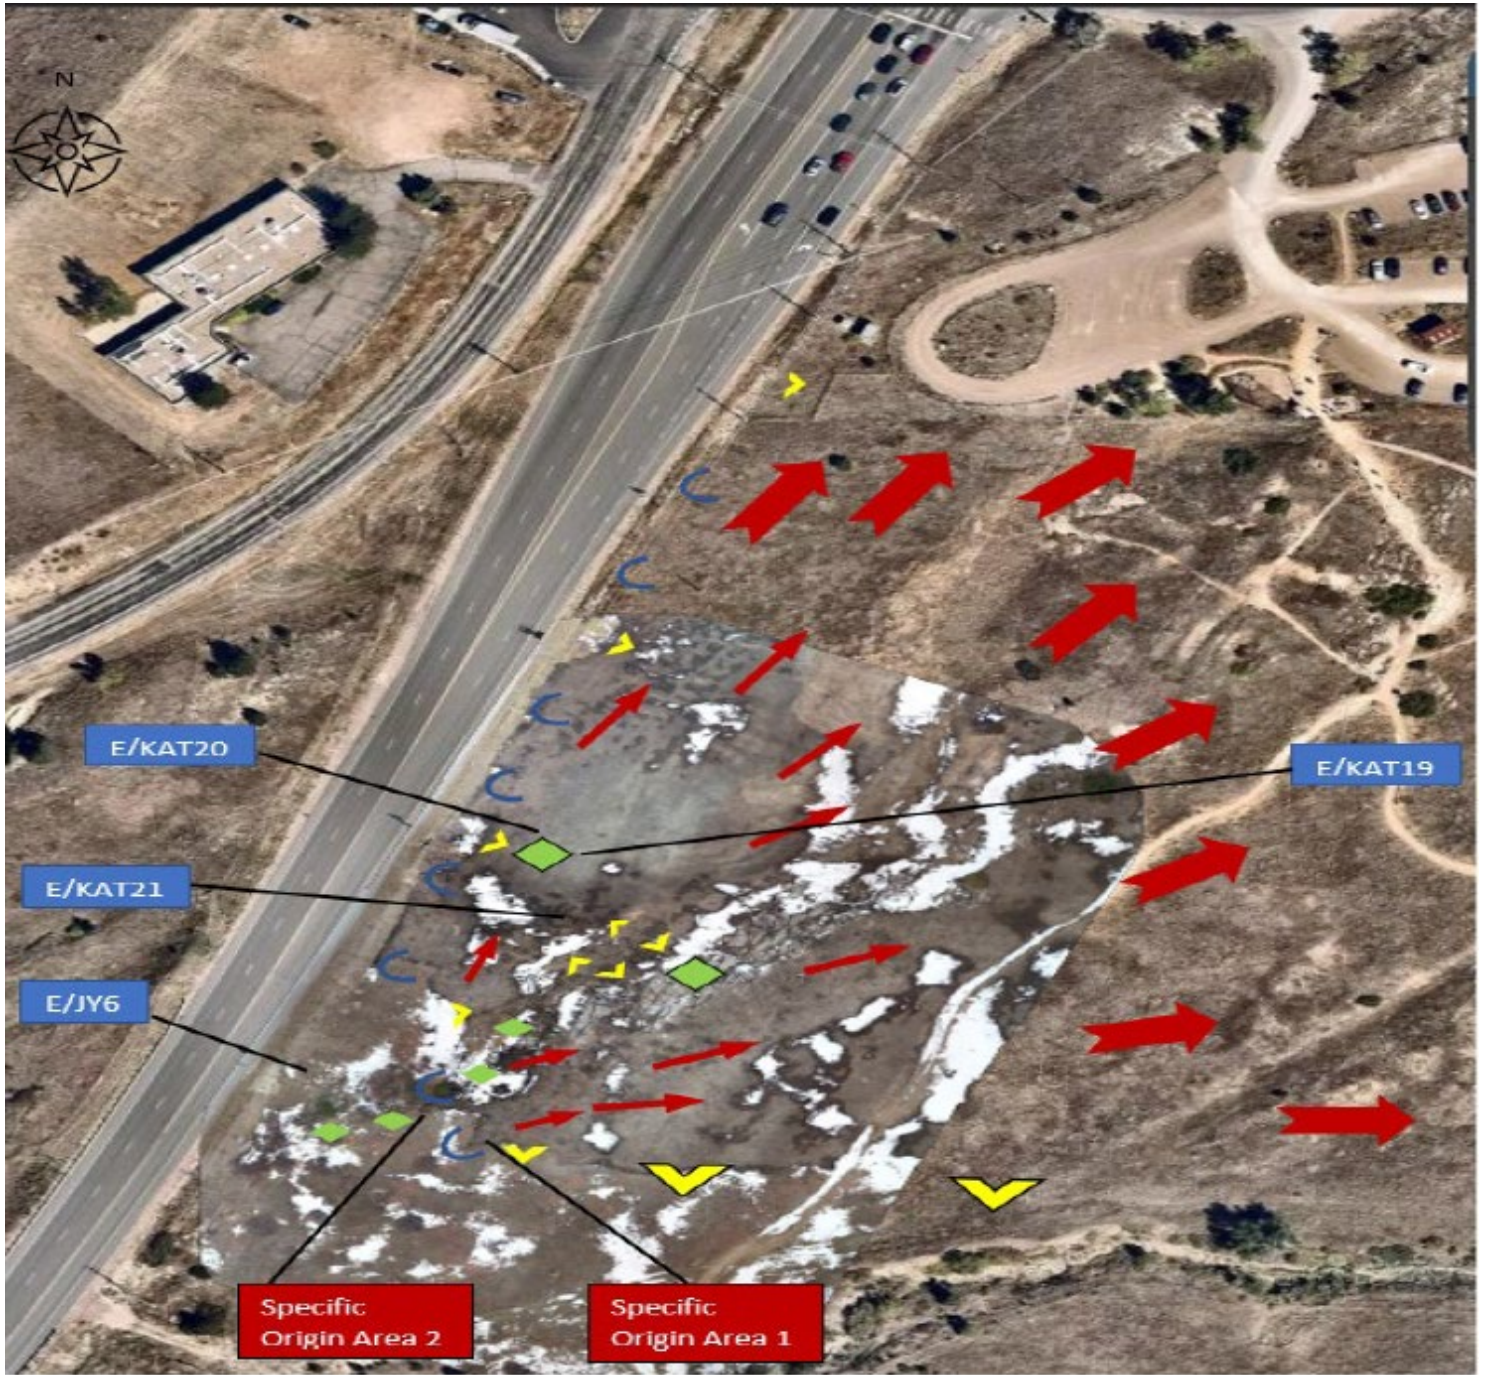
Exhibit 6

Investigators returned to the trailhead on January 14, 2022, to further examine the area near the disconnected powerline. At the base of the pole, agents located discarded aluminum lashing wires like those that would have been used to attach (or re-attach) a powerline to the crossarm. Nearby, investigators located two specific areas in which the Trailhead Fire may have ignited. Those two areas were 79.6 feet and 110.5 feet from the disconnected powerline. (*See Exhibit 6.*)
